### Parts Required:

### Step 1:

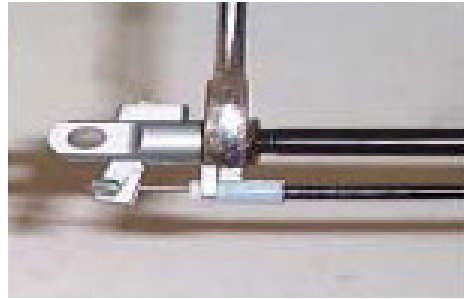
### Step 2:

Loosen the lock nut located on the stem of the gas cylinder next to the actuator. You will need to wind the stem further into the actuator if the chair is not tilting or reclining, (wind it clockwise) and wind it further out of the actuator if the chair is slowly sliding out of position. (wind it counter-clockwise).

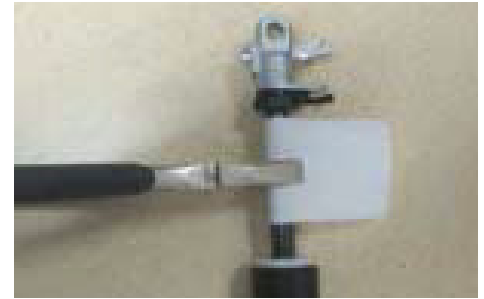
### Step 3:

Wind the stem in the correct direction one half turn. When viewing the cylinder with stem pointing towards you turn the stem clockwise to wind the stem out of the actuator and counter-clockwise to wind the stem into the actuator. A cloth, piece of vinyl strap, or some other protective material must be used to protect the sliding surface of the rod.

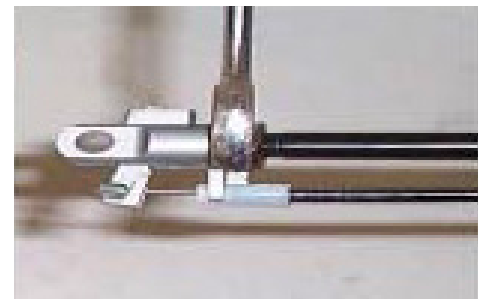
### Step 5:

Tighten the lock nut loosened in step 2.
