### Parts Required:

- F-ROD Foot Rod (width specific)
- F-SPRING Footrest Spring 3.25" Long

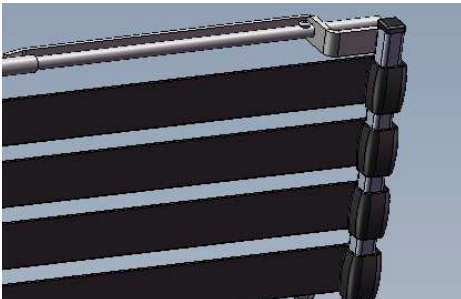
### Step 1:

Loose the #8 x  $\frac{3}{8}$  Pan quad self-tapping screw attached to the footrest rod using a #2 Robinson or Phillips screw driver to completely remove the defective footrest rod. (Set screw aside for re-use).

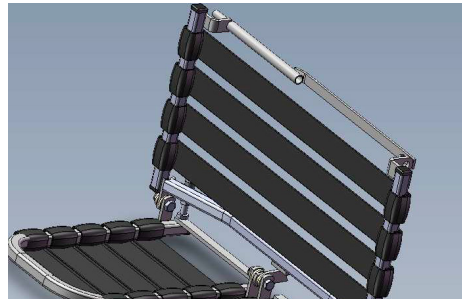
### Step 2:

Slightly turn the footrest on an angle to slide the footrest spring out of the frame portion, where the footrest rod was inserted and discard.

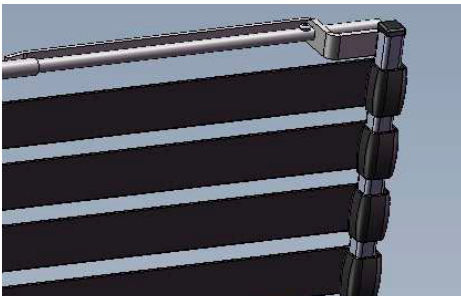
### Step 3:

Slide the replacement footrest rod into the cylinder tube, with the hole facing upwards, the same way it was removed in Step #1.

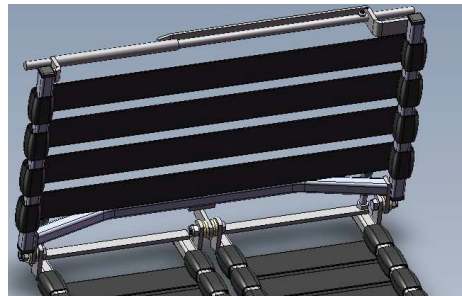
### Step 4:

Insert and tighten the #8 x  $\frac{3}{8}$  Pan quad self tapping screw the same way it was removed in Step #1.
